DUNMORE NO. 3 DAM

NDI ID NO. PA-00376

PENNSYLVANIA GAS AND WATER COMPANY

PHASE I INSPECTION REPORT
NATIONAL DAM INSPECTION PROGRAM

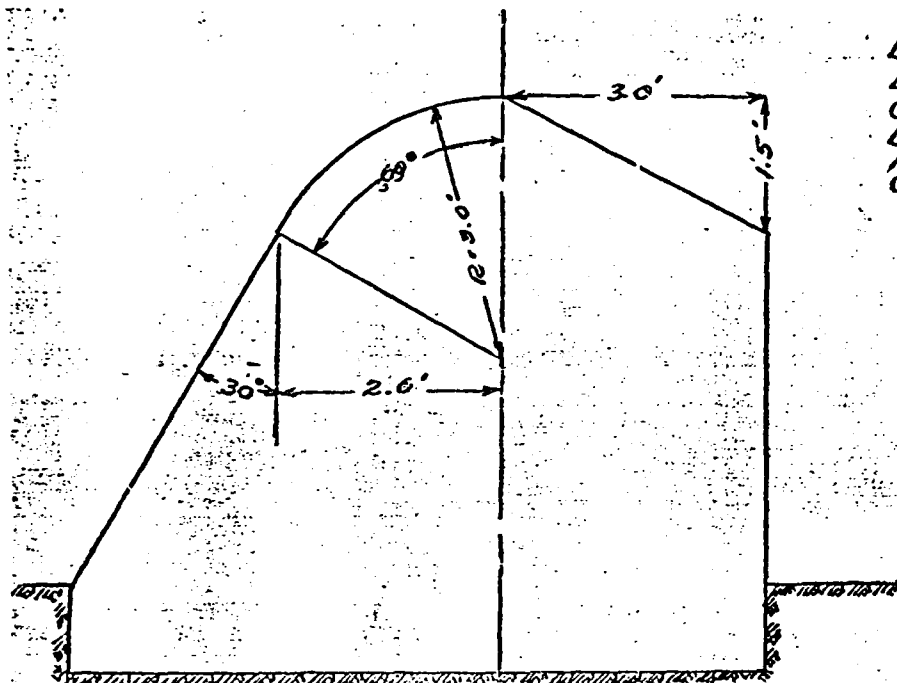
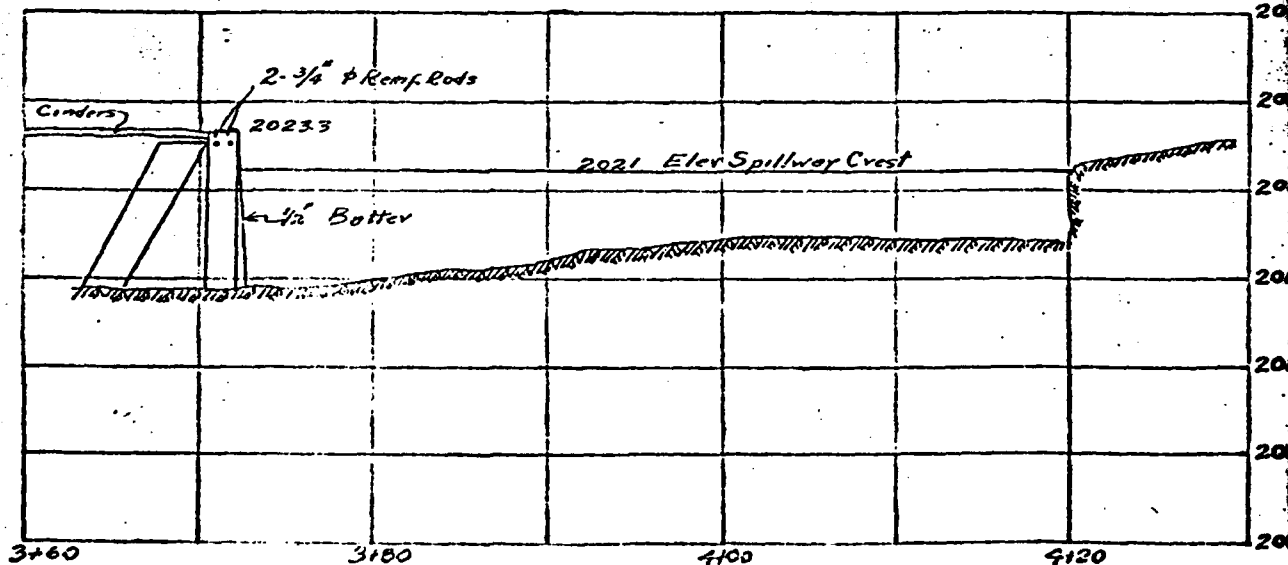
PLATE 4

(3) Appurtenant Structures. The spalling observed at the spillway is of little concern if it does not continue. The depression at the junction of the upstream embankment slope and the outlet works pipe could be cause for concern. The 1914 Pennsylvania Water Supply Commission Report states that the intake was a timber box structure, as shown in profile on Plate 5. No evidence of this structure was observed. The depression may have been the foundation of the structure. It also could be an indication of more serious problems.

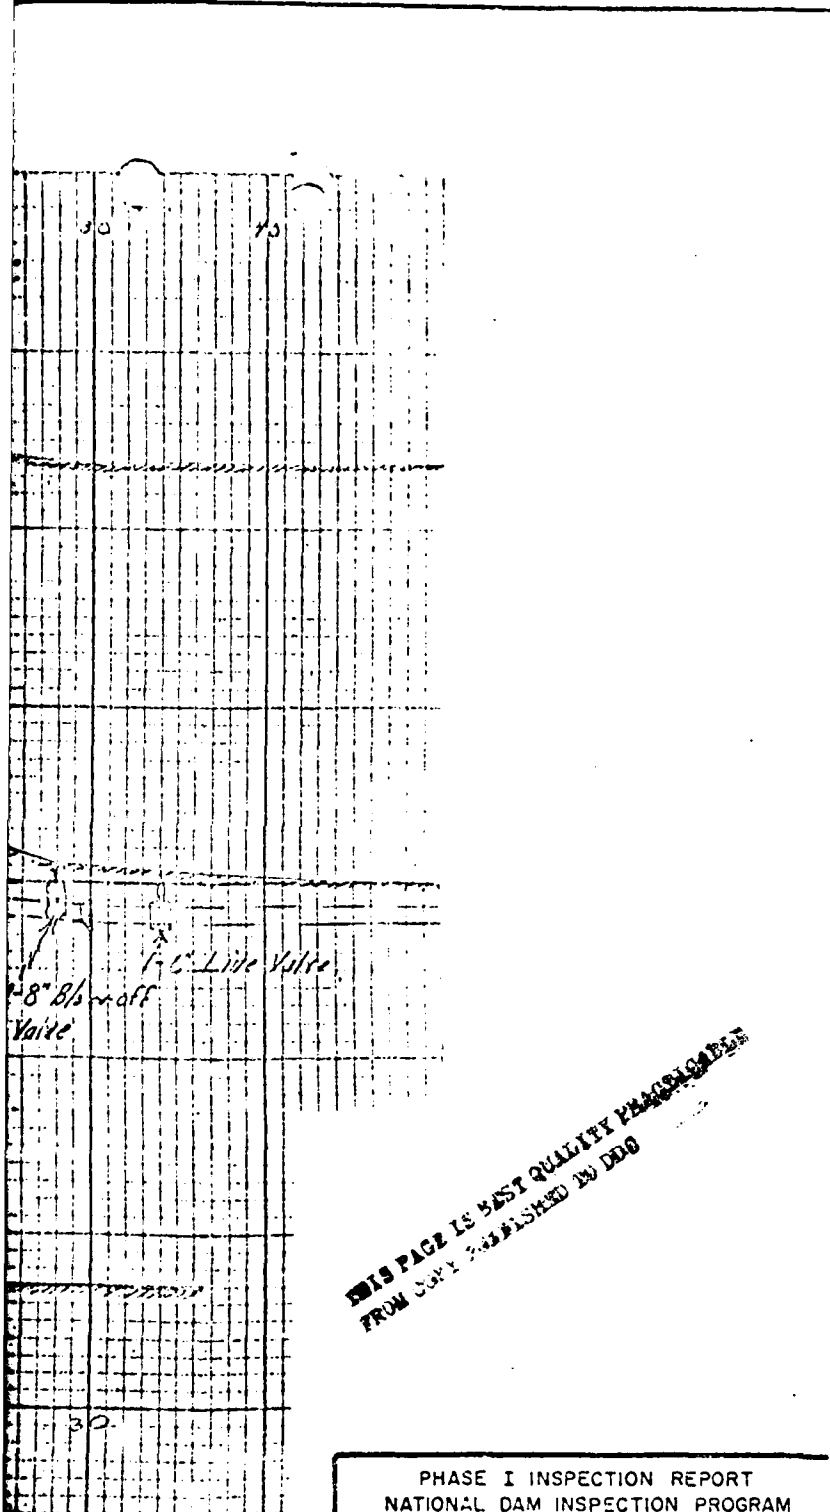
PHASE I INSPECTION REPORT
NATIONAL DAM INSPECTION PROGRAM
DUNMORE NO. 3 DAM
PENNSYLVANIA GAS AND WATER COMPANY
RIGHT EMBANKMENT SECTIONS
FEBUARY 1979 PLATE 5

The survey information in Appendix B and Plates 2, 5, and 6 indicate that the downstream slope is uniform at any one section but varies between sections. The steepest section has a slope of 1V on 1.5H and the flattest has a slope of 1V on 2.8H. The upstream slope also varies. It is about 1V on 1.3H at the steepest section and 1V on 2.4H at the flattest section.

The 1914 Pennsylvania Water Supply Commission Report states that there is no core-wall in the embankment, as far as is known. It is not known where the information on Plates 5 and 6 was derived. These plates are undated. The core-wall is described on these plates as "double 1-inch sheeting" with 6-inch by 8-inch stringers. The value of such a timber core-wall is dubious. Such a thin timber section cannot be considered to add significant shear resistance to the embankment. Its ability to act as a watertight structure is also doubtful. Furthermore, considering its age, its condition in the zone of a fluctuating phreatic surface must be questionable. It is not considered that the core-wall can be relied on to act as an effective cutoff.
